## Trail/Road Coating for Snowmobile Crossings

**Project Number** 2012-02

**Agency** Scott County  
600 Country Trail East  
Jordan, MN 55352

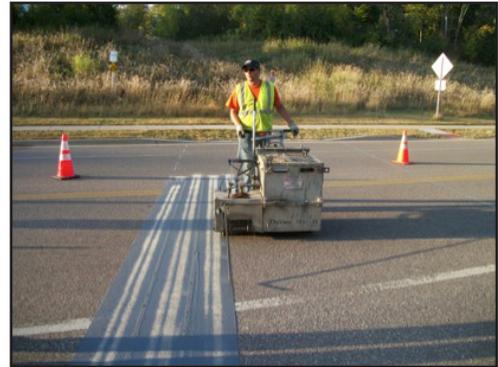
**Solution** The county installed a thermoplastic coating attained from P.K. Contracting in Troy, Michigan, to minimize or eliminate this problem on roads and trail systems.

**Procedure** The material was placed at crossing locations on roads and trails in September 2013, prior to the winter snowfall season. The product was placed in a hopper on a flatbed truck and heated to 420°F. It was then transferred to a small pushcart machine, which placed the material and scattered silica sand behind. Silica sand was also spread by hand to ensure even distribution.

The product was placed in a series of 12-inch strips starting from centerline. Three layers were placed with each layer offset 6 inches in from the previous layer to prevent snowplows from peeling off the material. Silica sand was placed along each strip to increase the bond between layers, to prevent vehicle tires from peeling it up before it fully cured, and to provide friction for drivers. The process took approximately an hour in each location, and traffic was allowed on the roadway within 10 minutes of placement.

**Results** County officials kept track of how many snowmobiles crossed the roads and trails for two years and evaluated the condition of the coating and pavement each spring. The coating held up very well through both winters, requiring only basic maintenance procedures such as plowing and salting. Damage at locations where snowmobiles cross was very minimal compared to locations without the thermoplastic coating.
